# OLMSTED ENVIRONMENTAL SERVICES, INC

Mold Survey: 240 E 18th St, Brooklyn, NY, United States

Survey Date: July 24, 2023

PHOTOGRAPHS  
240 EAST 18<sup>TH</sup> STREET BROOKLYN NY  
July 24, 2023

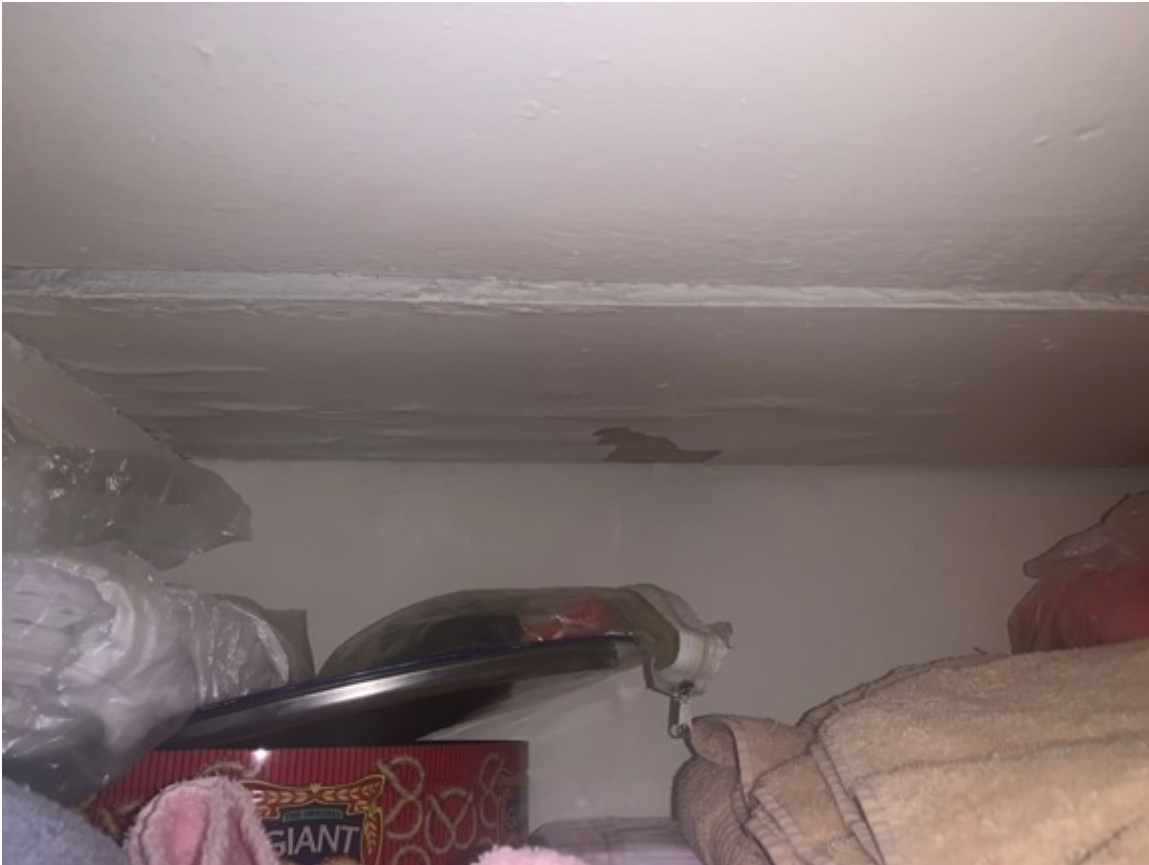
1. The plaster in the closet and living room was dry when tested with a moisture meter.
2. A bulk sample was collected from the damaged paint on the closet wood shelves. The sample, number 240E183C-1, was cultured for mold and had 550,000 colony-forming units per gram (CFU/g) dominated by *Aspergillus sydowii*. This indicates mold growth under the new paint.

damage to the bedroom closet 3C

1. *Remove the clothes from the bedroom closet and launder or dry clean*
2. *Remove, clean and scrape lose paint from the wood shelves in the closet.*
3. *Scrape the damaged paint and plaster and remove wood trim in the back wall and ceiling of the closet.*
4. *Scrape the damaged paint and plaster and remove wood trim in the living room.*

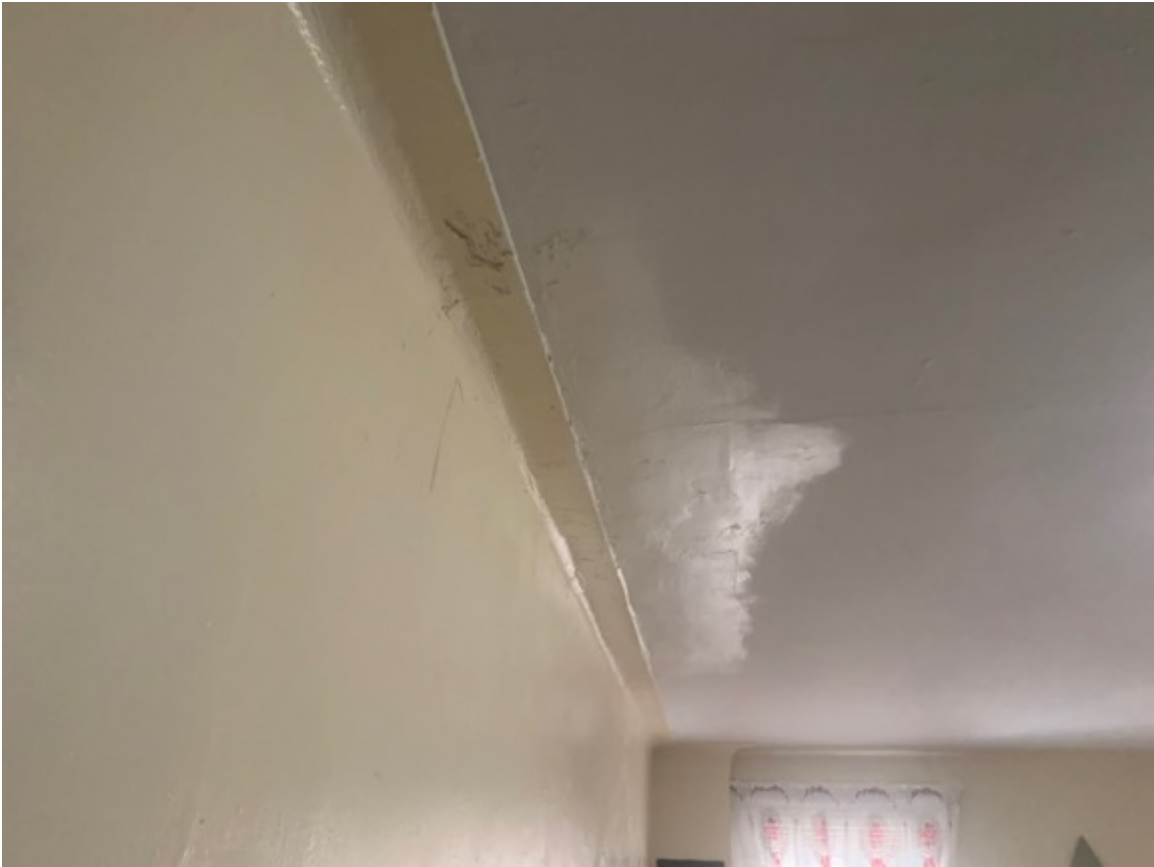
3. In the living room a bulk sample was collected from the wall where water damaged. The sample, number 240E183C-4, had 2 million CFU/g dominated by *Aspergillus sydowii*. This indicates mold growth under the new paint.

damage and moldy plaster in the living room of 3C

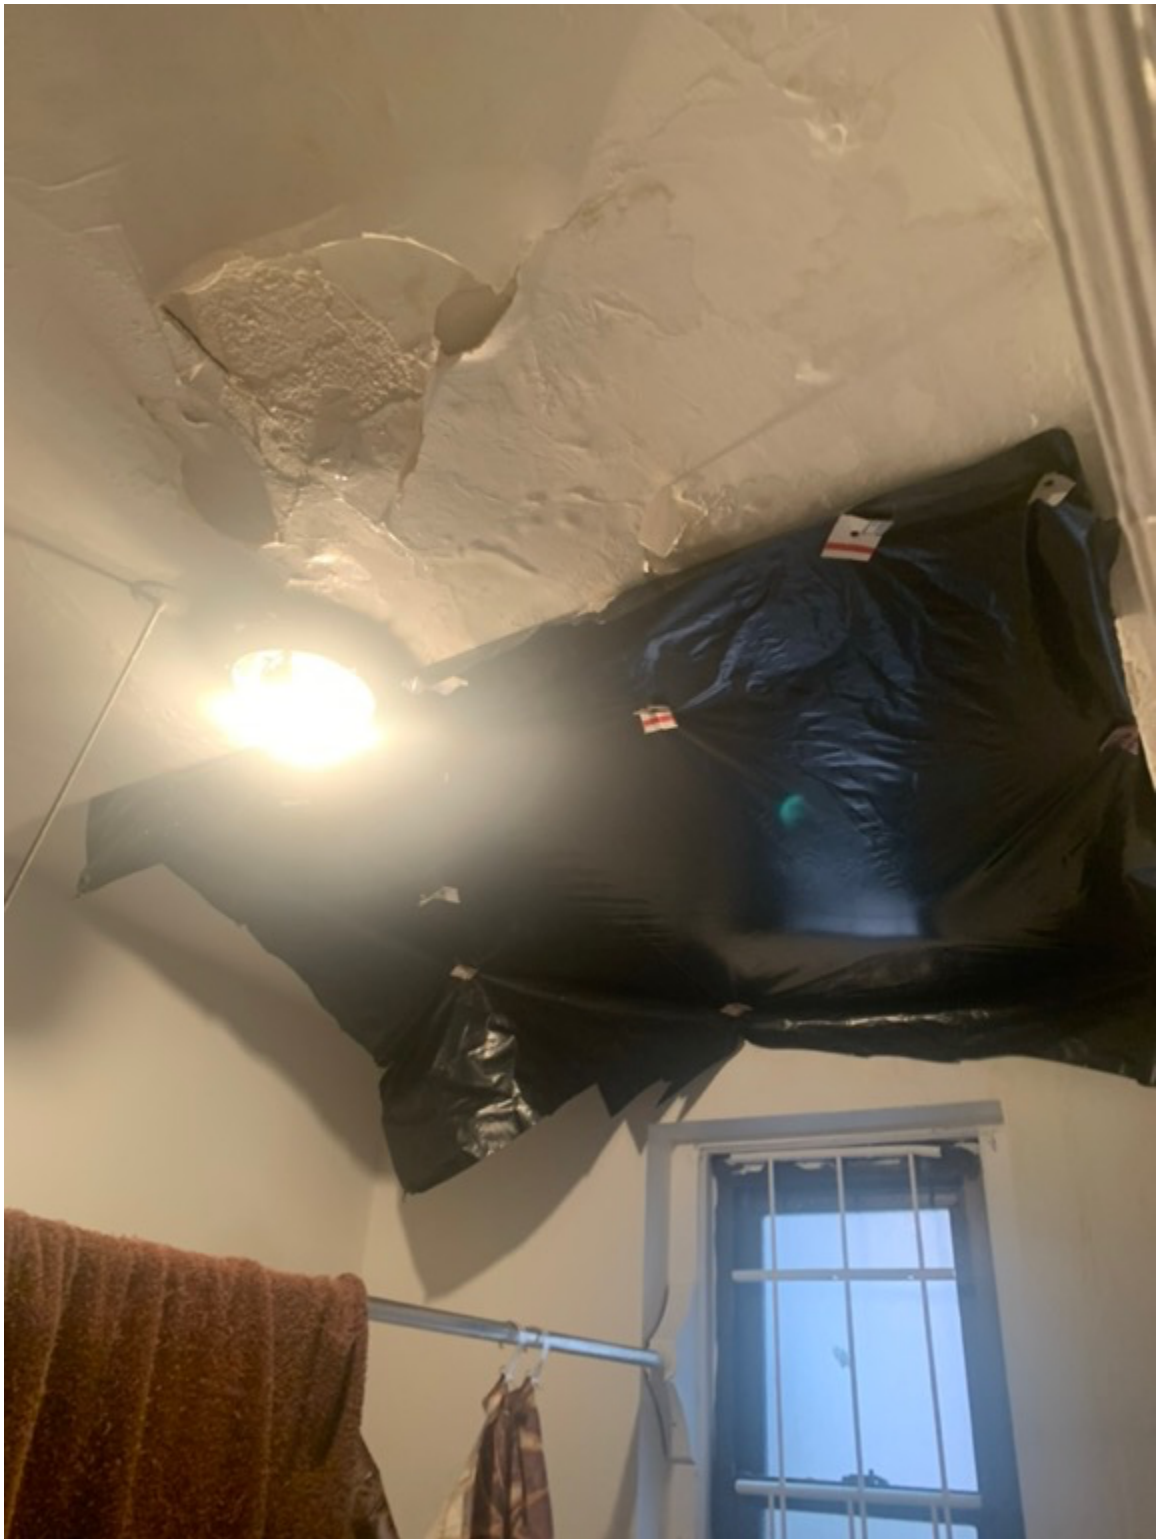
sewage leak in 4A bathroom

- *Gut renovate the bathroom down to the substrate. Remove walls and ceilings.*
- *Remove the water damaged plaster ceiling in the hallway outside the bathroom.*
- *Remove the wall between the bathroom and hallway*
- *Remove the kitchen floor tiles and clean the plywood.*

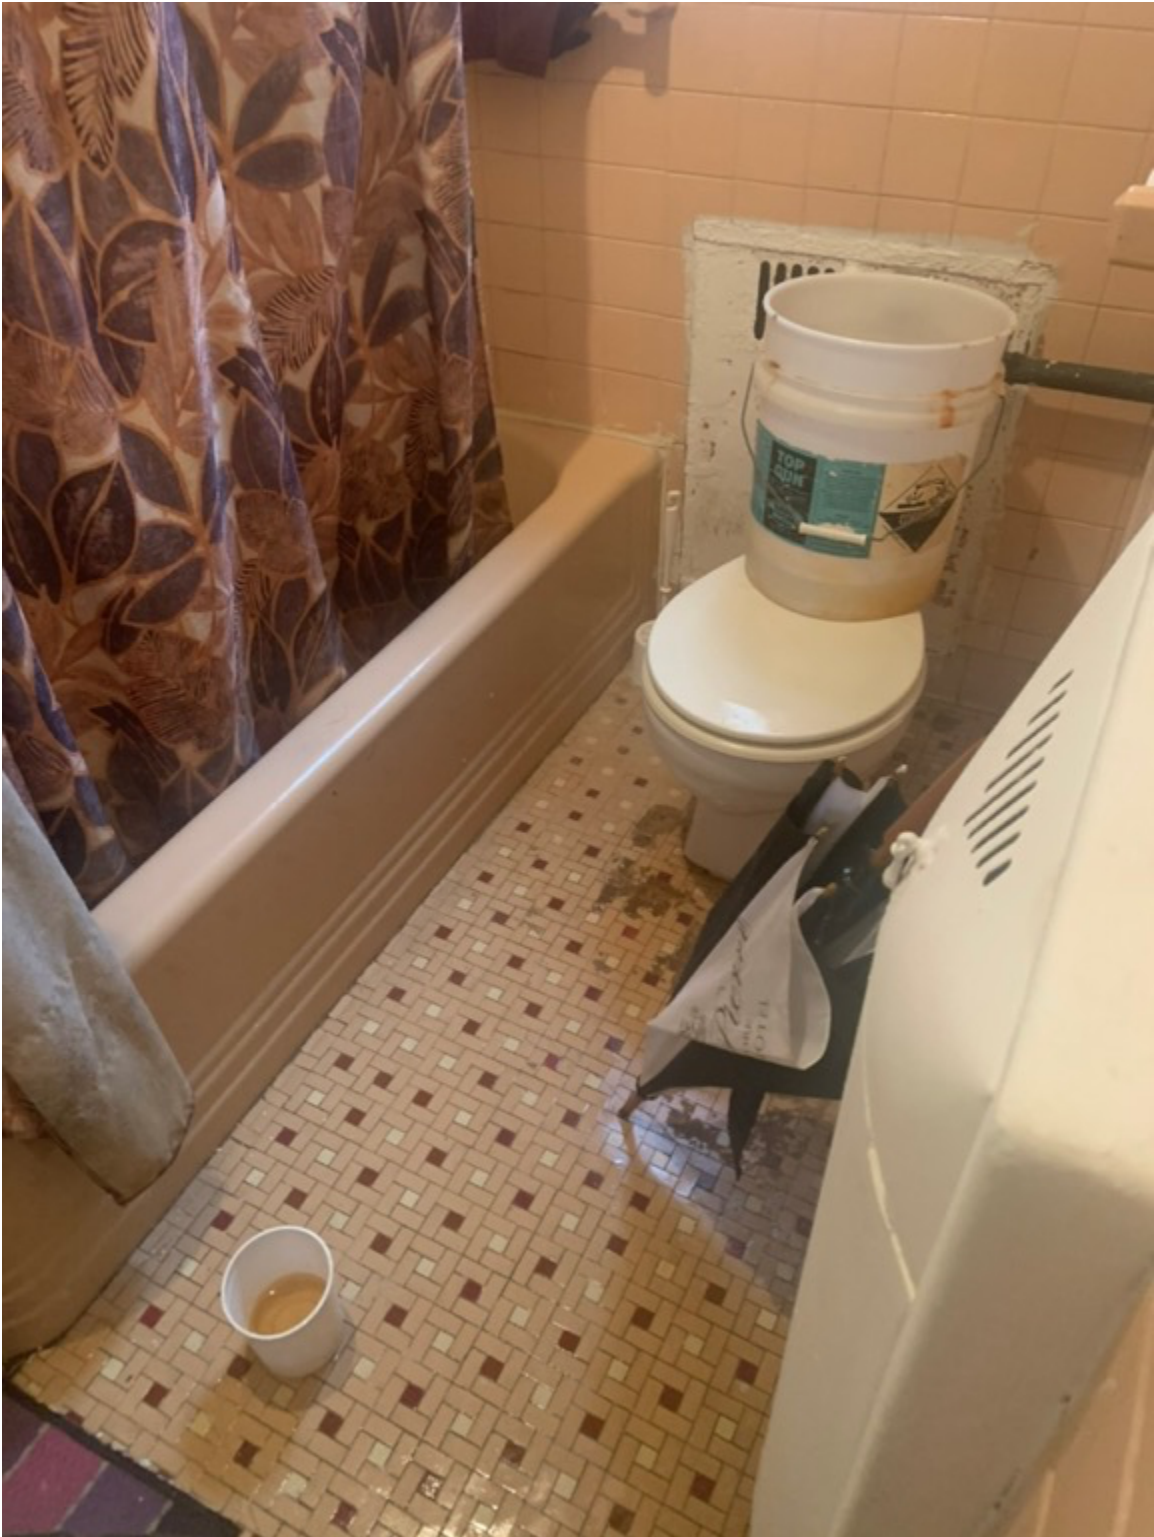
1. The plaster ceiling in the hallway and bathroom tested wet at 99%, indicating an active leak. There was standing water on the bathroom floor and above the plastic. The walls in the bathroom were wet.

the floor is wet from dripping sewage in apartment 4A bathroom

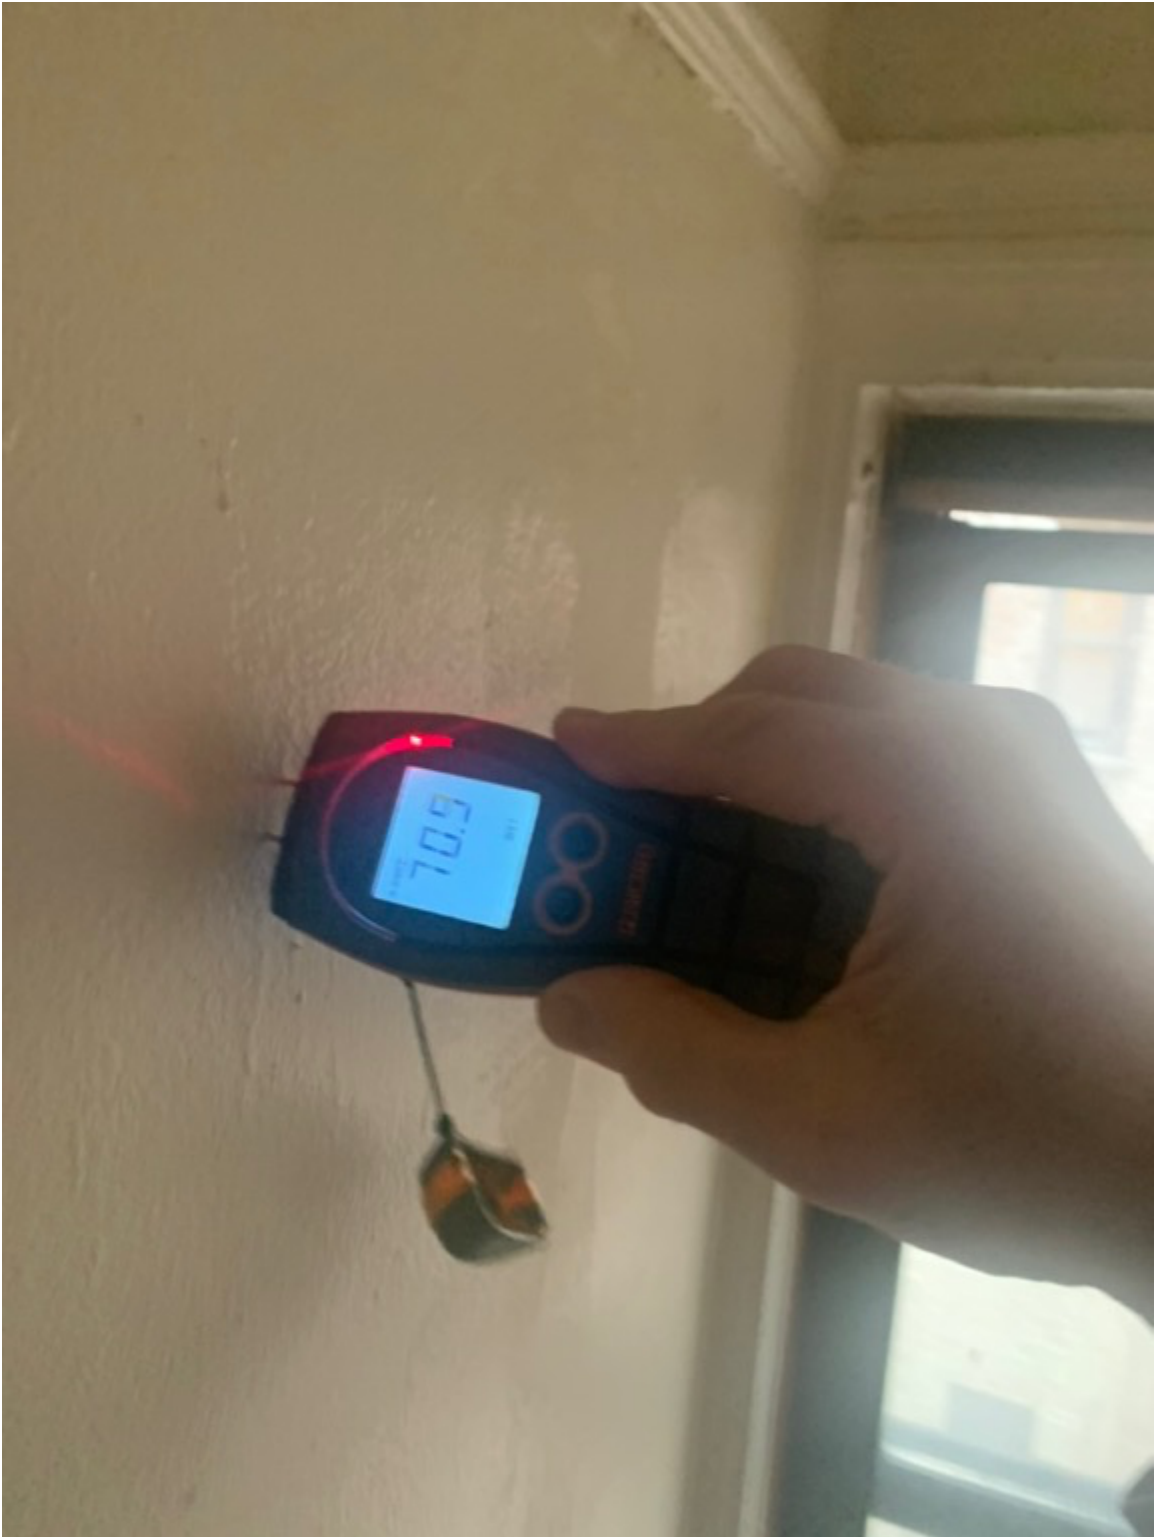
2. A bulk sample was collected from the wet and damaged plaster in the hall outside the bathroom. The sample, number 240E184A-7, was analyzed by the lab and reported to be positive for the presence of fecal coliform bacteria, total coliform and *E coli*. This indicates the leak is sewage. The guidelines for cleaning up sewage recommend the removal of all impacted porous materials. Sample 7 was also cultured for mold spores. The sample had 470,000 colony-forming units per gram (CFU/g) dominated by *Aspergillus sydowii* and *Aspergillus versicolor*. This indicates mold growth.

moisture in the hallway wall in 4A long wall shared with the bathroom

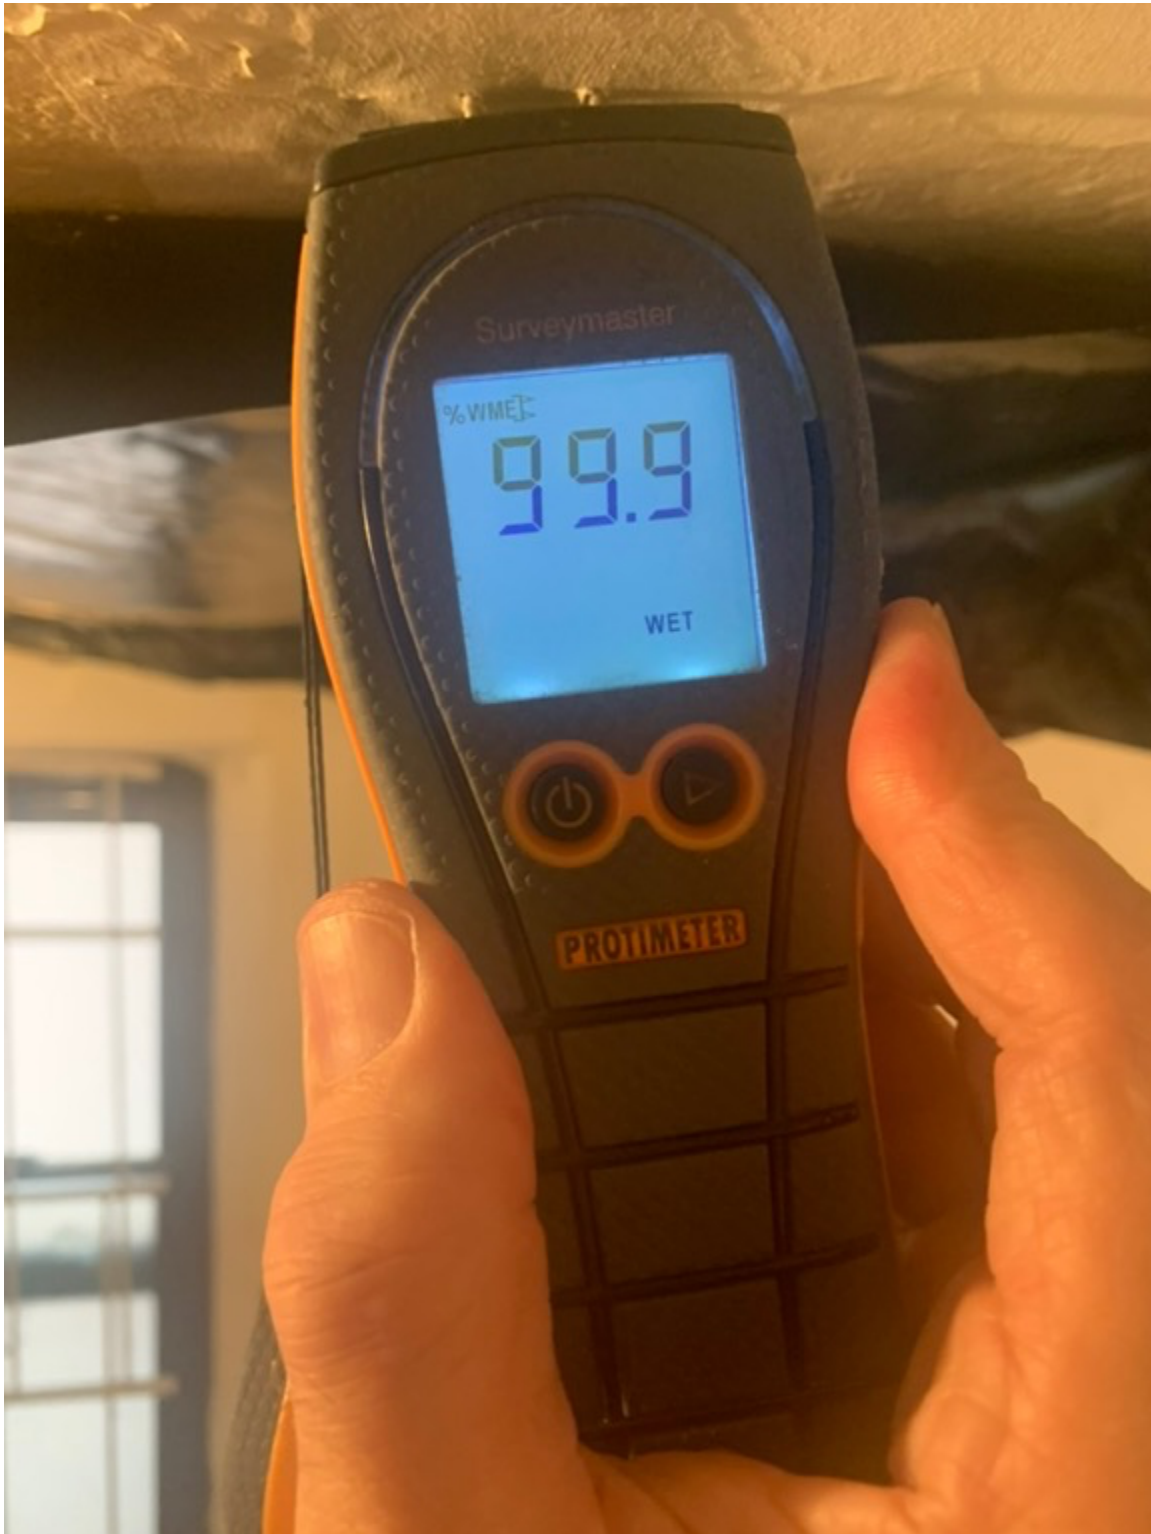
soaked bathroom ceiling 4A

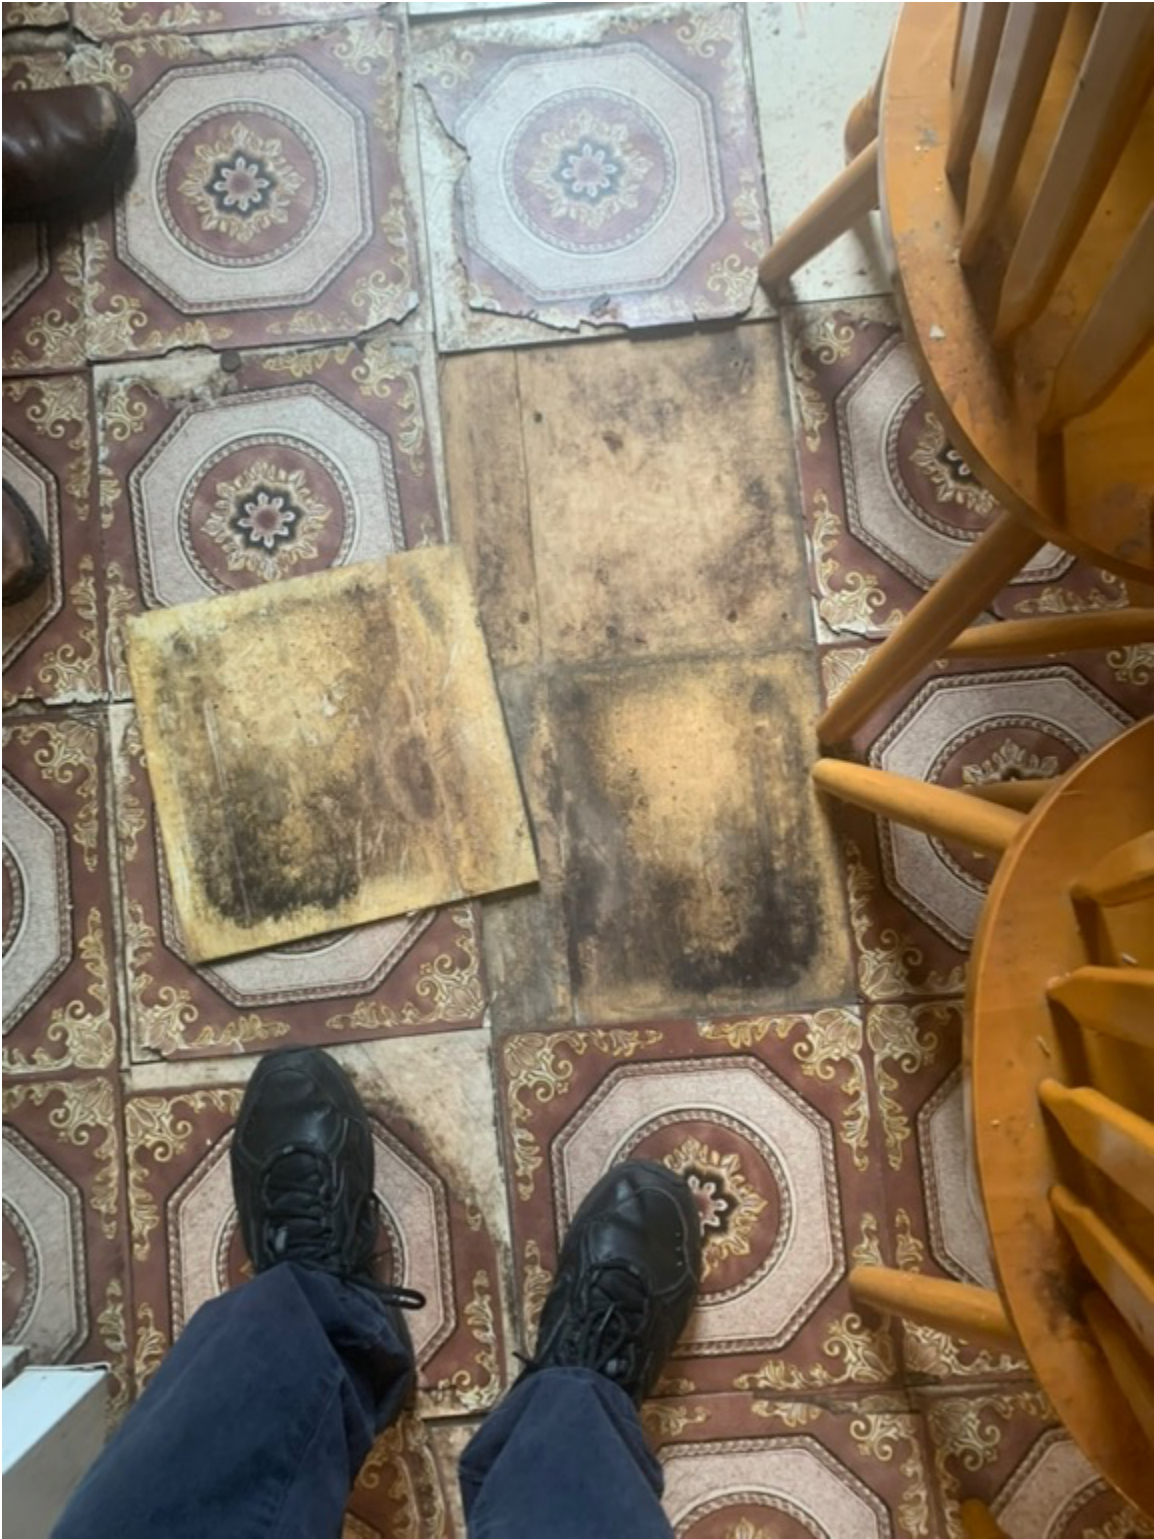
5. In the kitchen, the floor was water-damaged from past flooding. There is visible mold on the plywood beneath the vinyl tiles. A tape lift from the plywood, number 240E18-4A-5, had ascospores and ascomata of an ascomycete and spores, conidiophores and hyphae of *Aspergillus*. This indicates mold growth.

Moldy floor in the kitchen in 4A

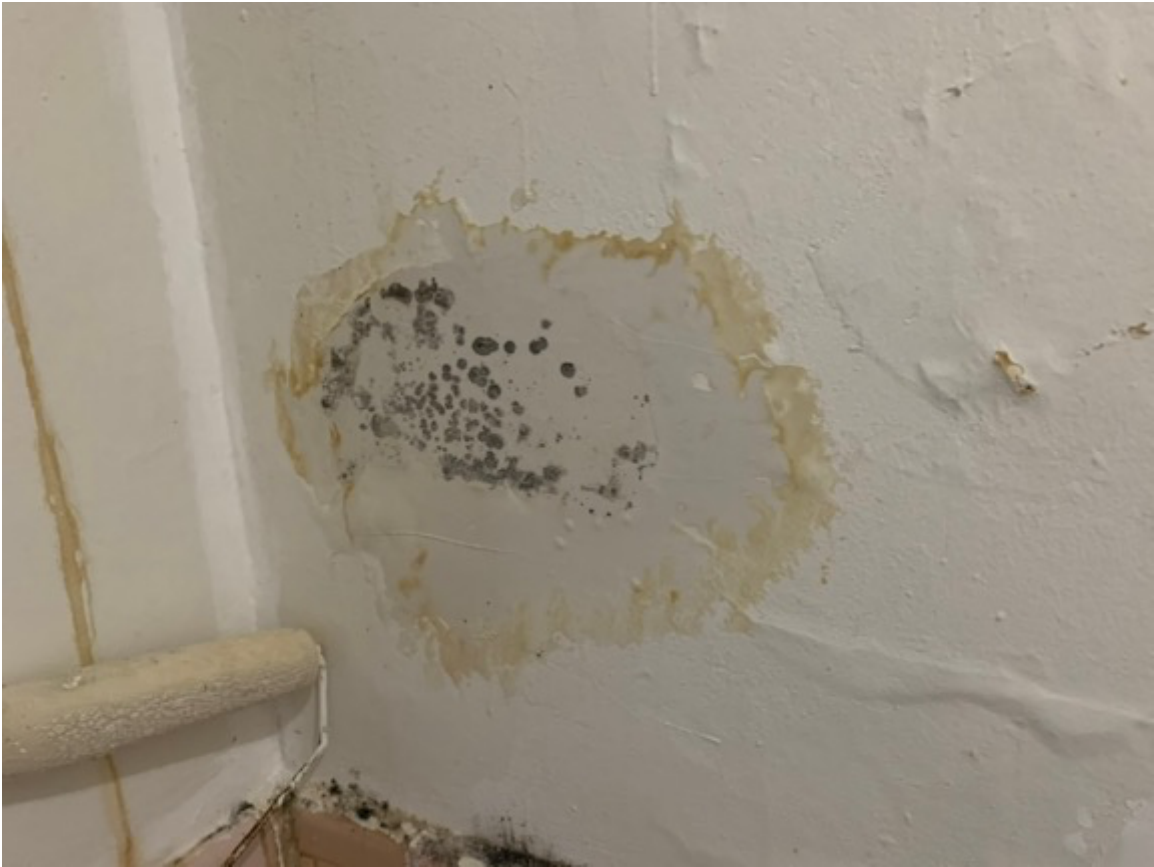
visible mold in the bathroom of 3A – there is an active sewage leak

- *Gut renovate the bathroom down to the substrate. Remove walls and ceilings.*
- *Remove the water-damaged plaster ceiling in the hallway outside the bathroom.*

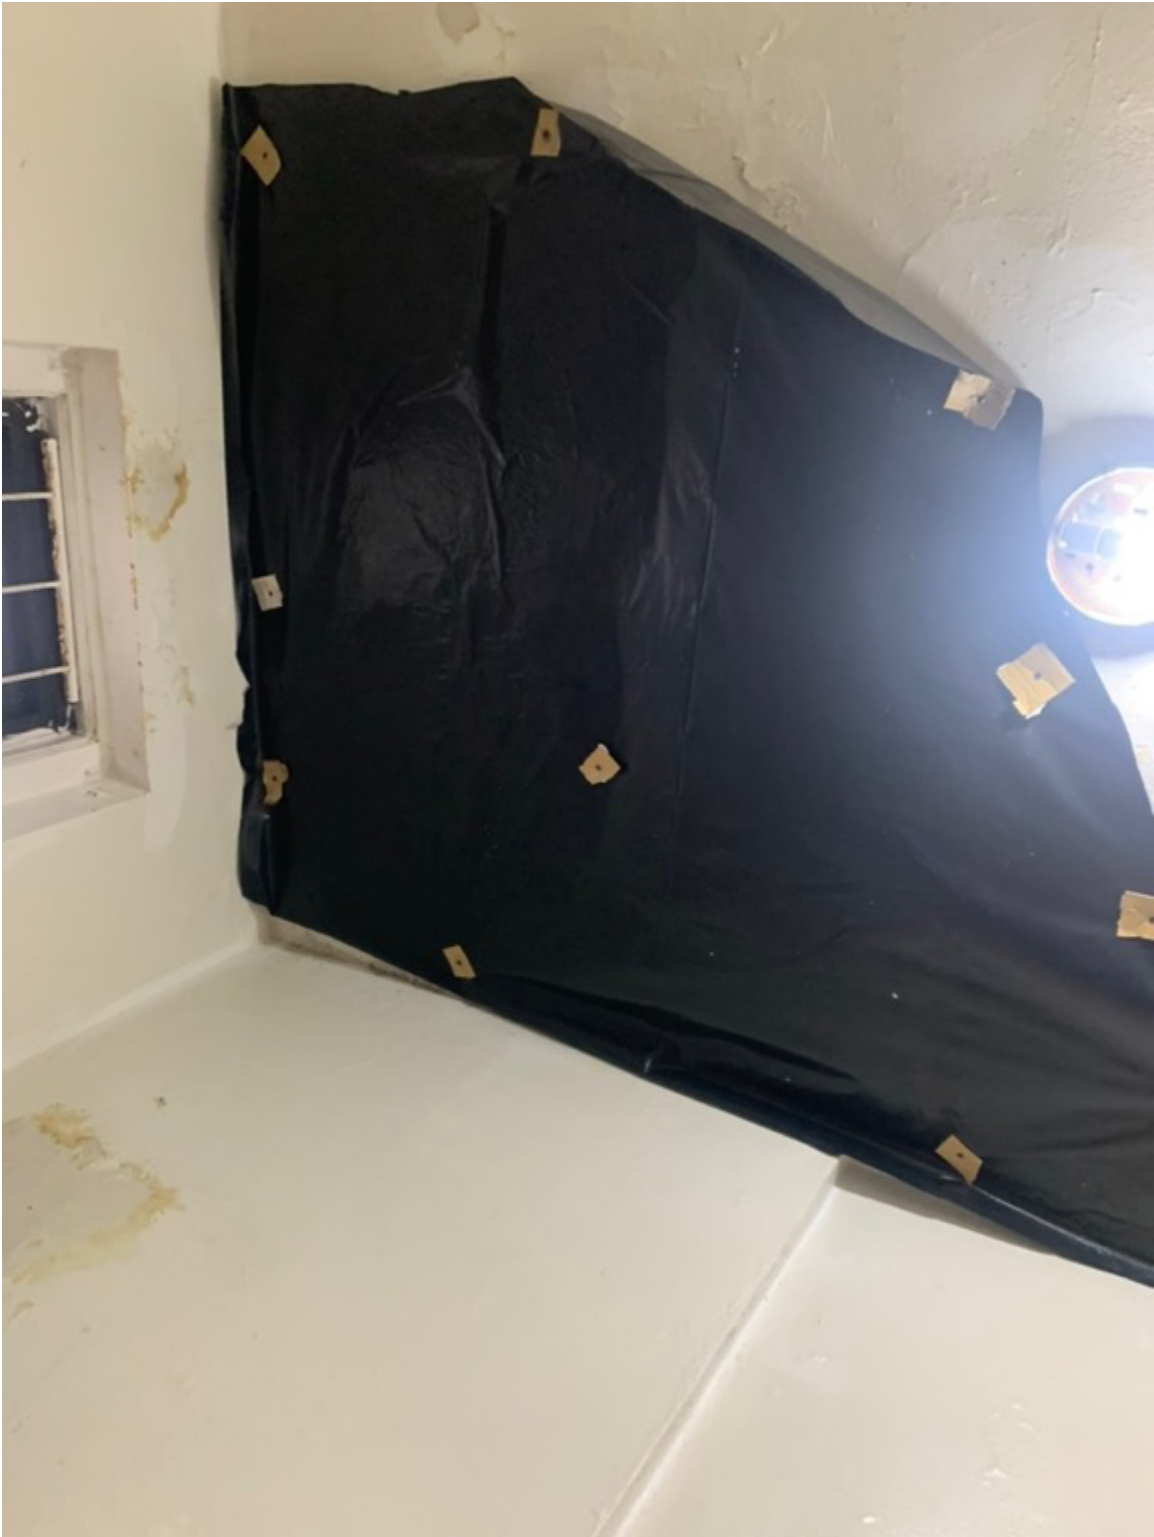
- 3. A bulk sample was collected from the wet and damaged plaster ceiling in the bathroom. The sample, number 240E183A-12, was analyzed by the lab and reported to be positive for the presence of total coliform. The sample was also cultured for mold and had 5.1 million CFU/g dominated by *Cladosporium* and *Aspergillus sydowii*, indicating mold growth.

bathroom ceiling in 3A – sewage is leaking

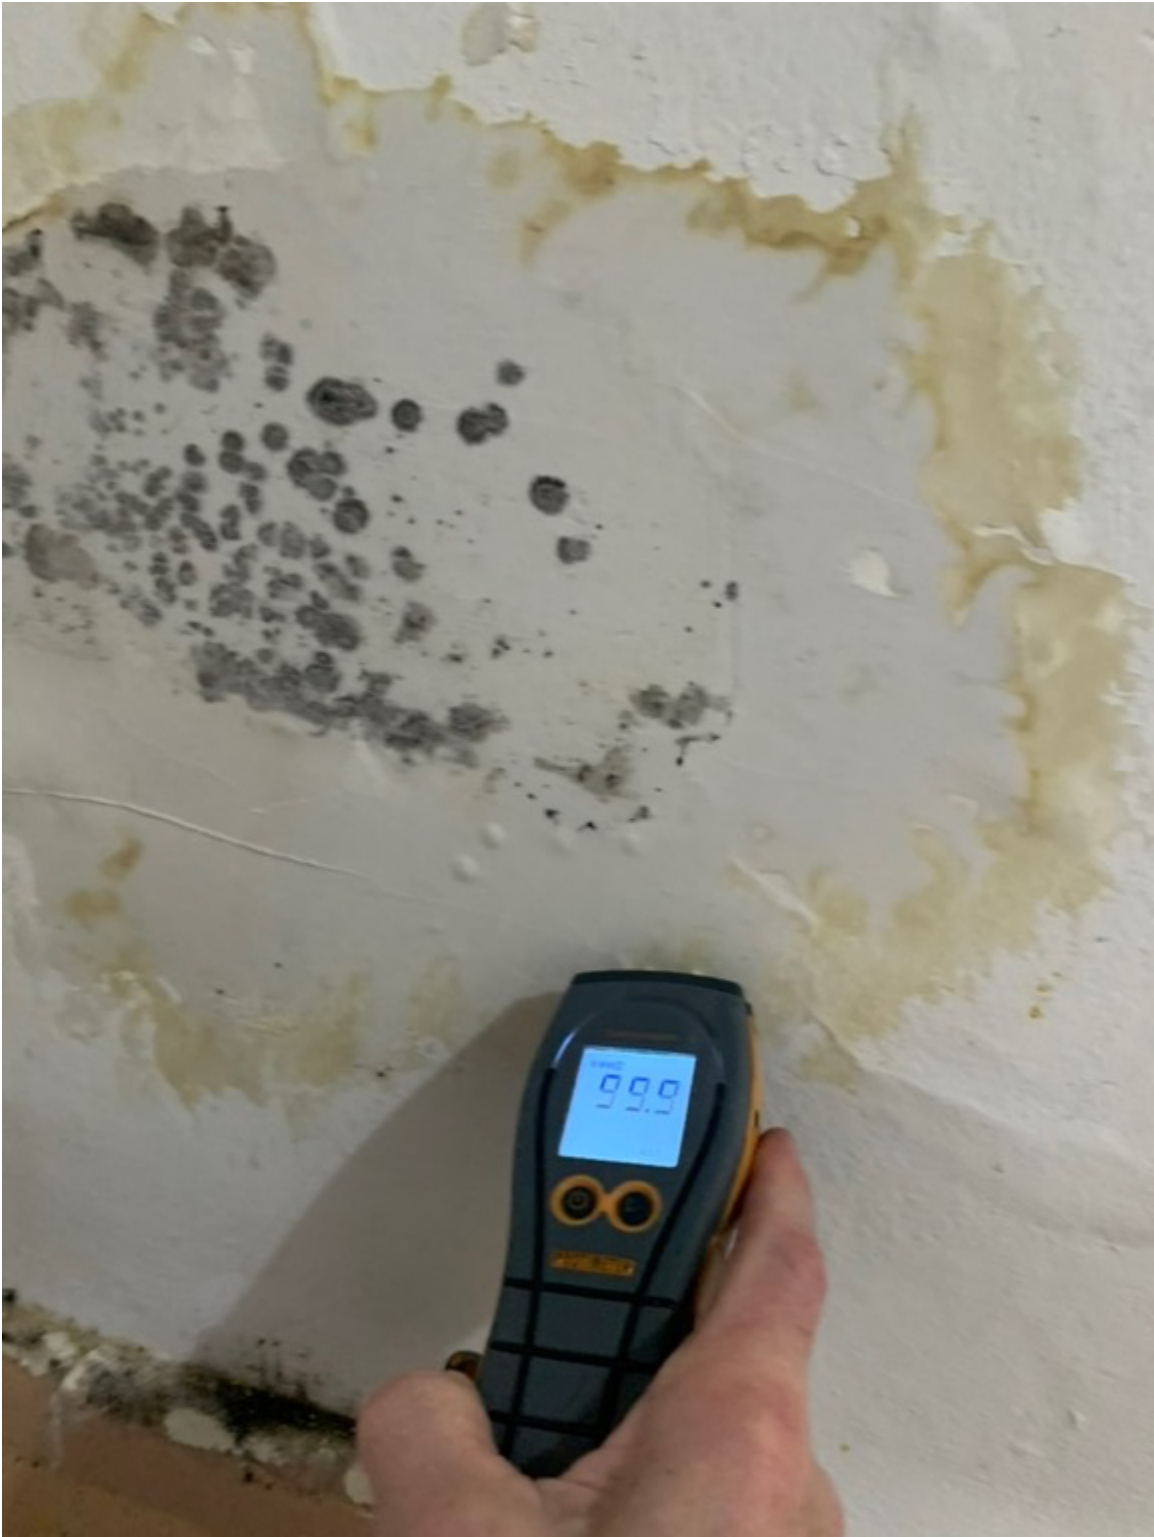
- 4. Another bulk sample was collected from the wet wall in the bathroom. The sample, number 240E18-13 was positive for total coliform. This indicates the leak is sewage. The guidelines for cleaning up sewage recommend the removal of all impacted porous materials. Sample 13 was also cultured for mold spores. The sample had >14 million colony-forming units per gram (CFU/g) dominated by *Penicillium*. This indicates mold growth.

3A bathroom walls are soaked and saturated with sewage

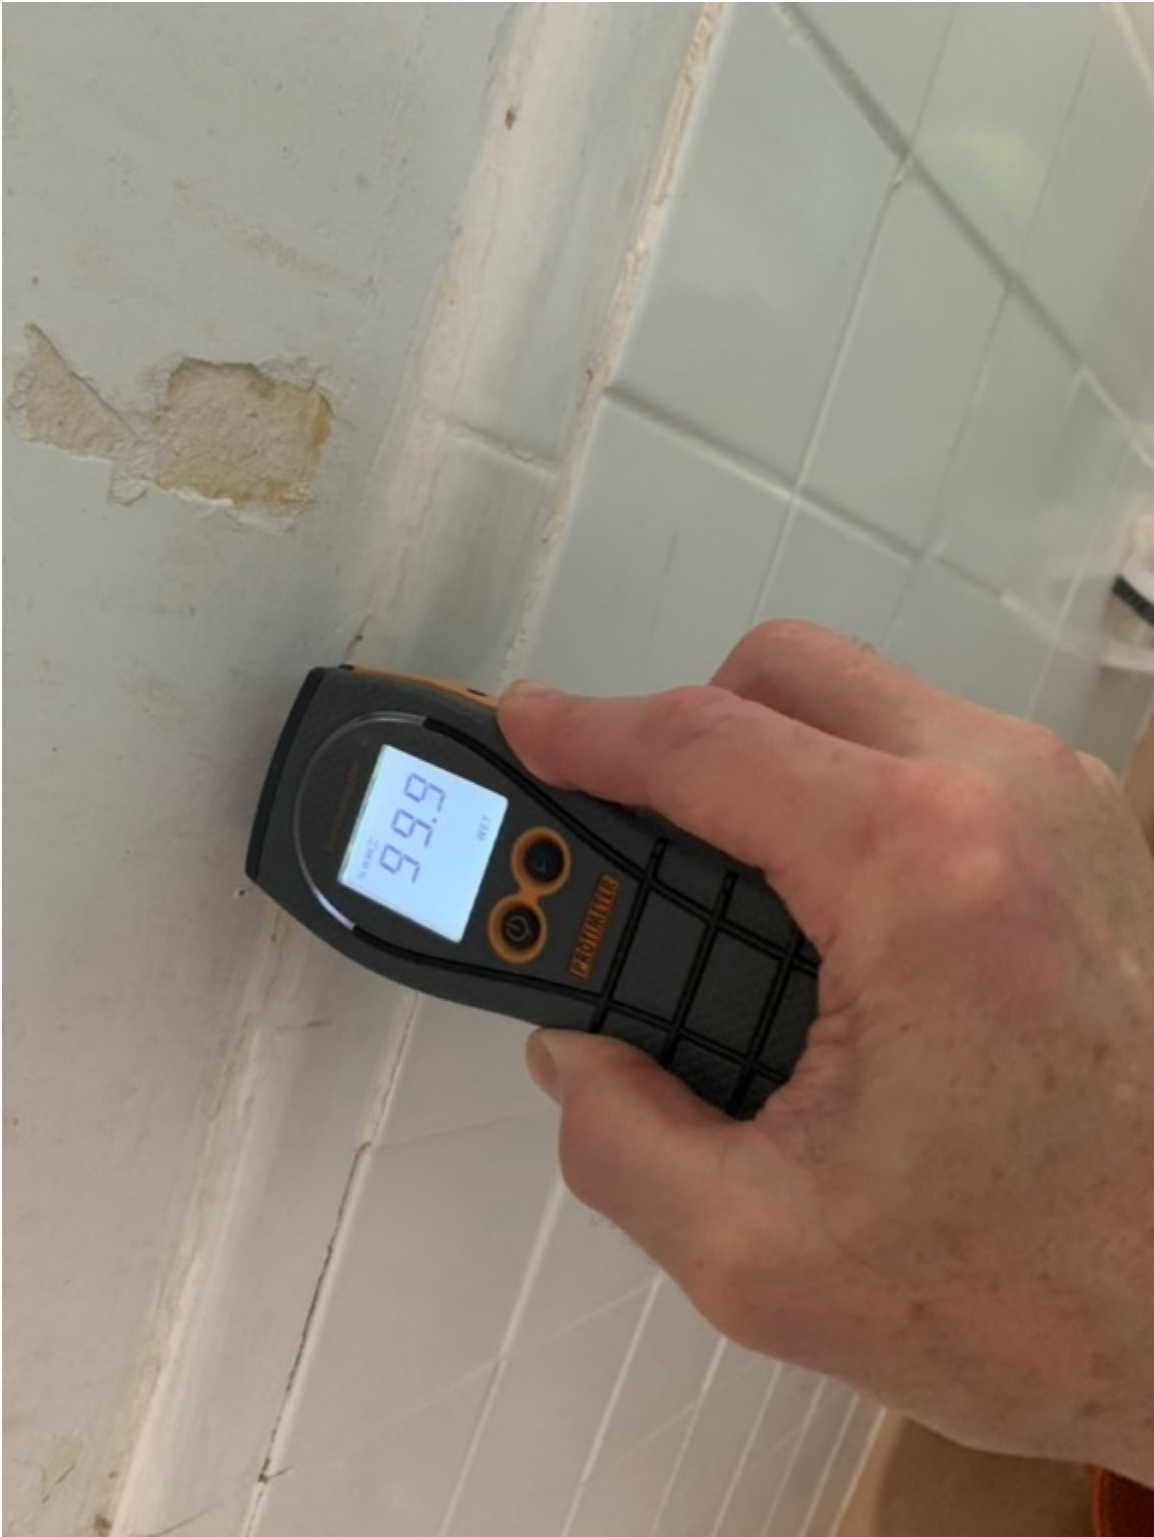
1. The wall above the tiles in the bathtub area tested damp with moisture meter measuring 99%.
2. The bathroom shower reportedly does not work and has been abandoned. There is visible mold on the grout in the tiles shower ceiling and walls. A tape lift from the ceiling in the shower, number 240E18-16, was analyzed by Ed Olmsted and Prestige. The sample had growth of *Cladosporium*.

apartment 6B – the walls are soaked around the tub

1. *Clean the shower tiles with a strong detergent.*
2. *Repair the shower and regrout the tiles so that it works properly and does not leak.*
3. *Clean the walls above the tiles in the bathroom and repaint.*
4. *Replace the kitchen sink cabinet.*

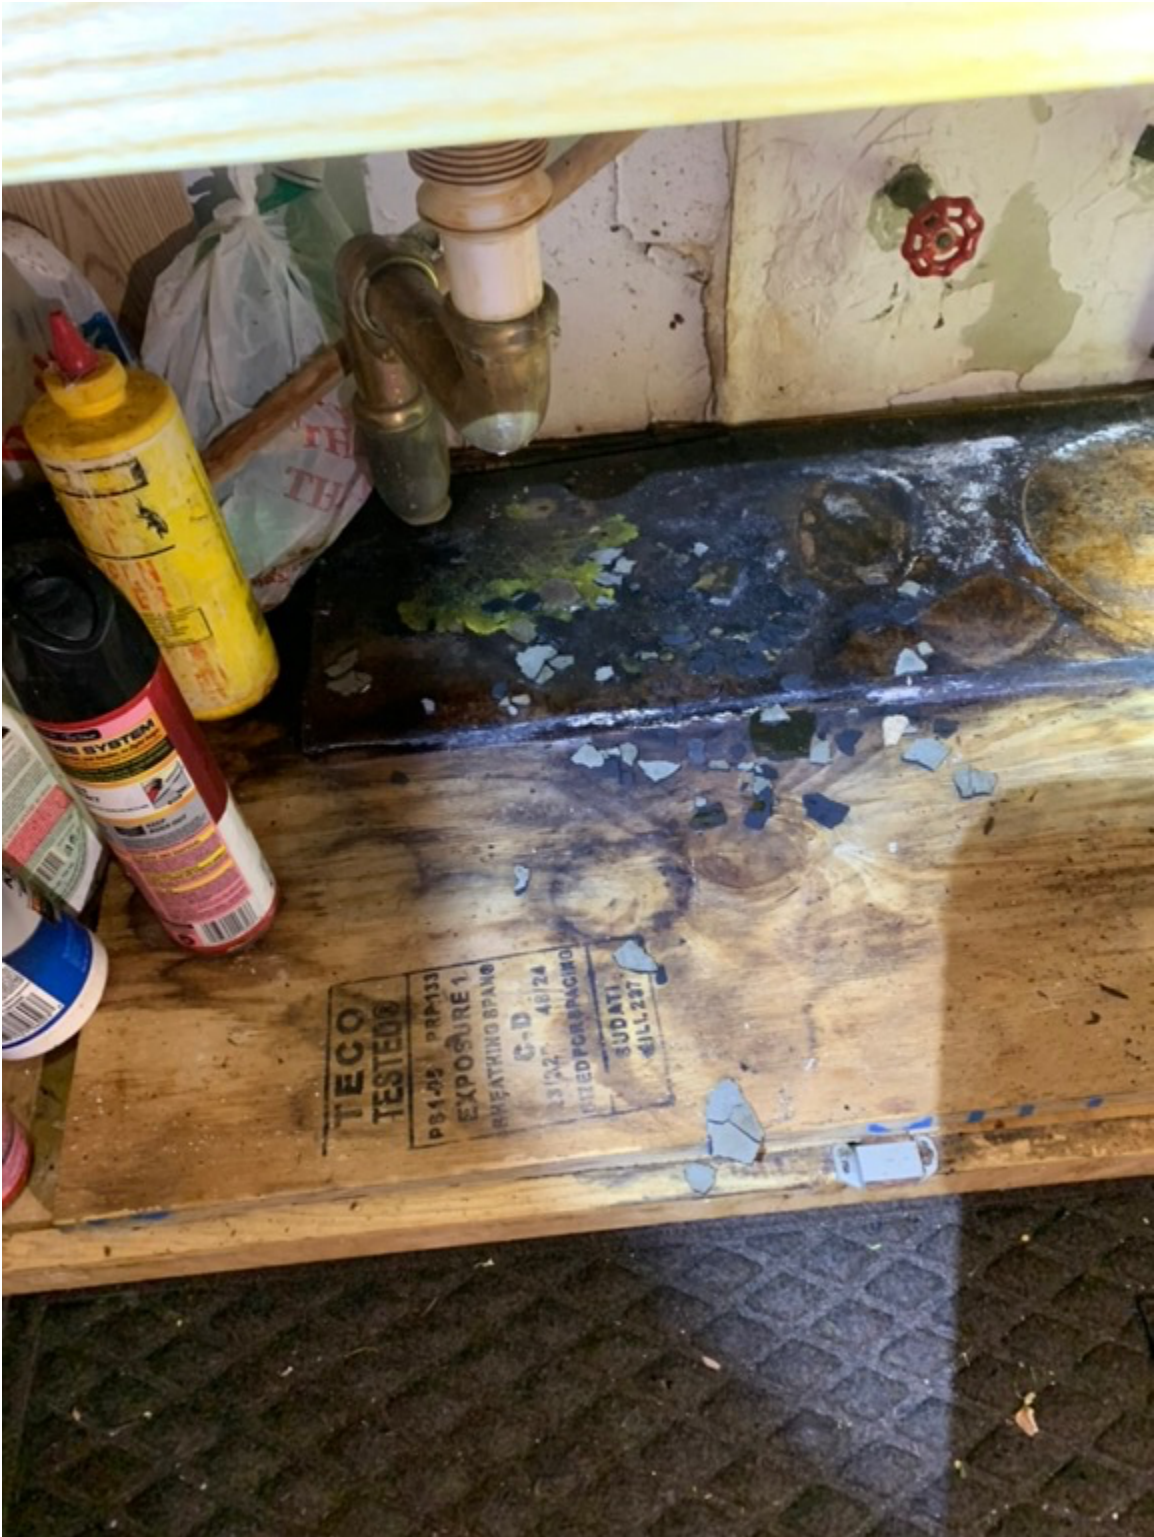
The sink in the kitchen in 6B is water-damaged and moldy

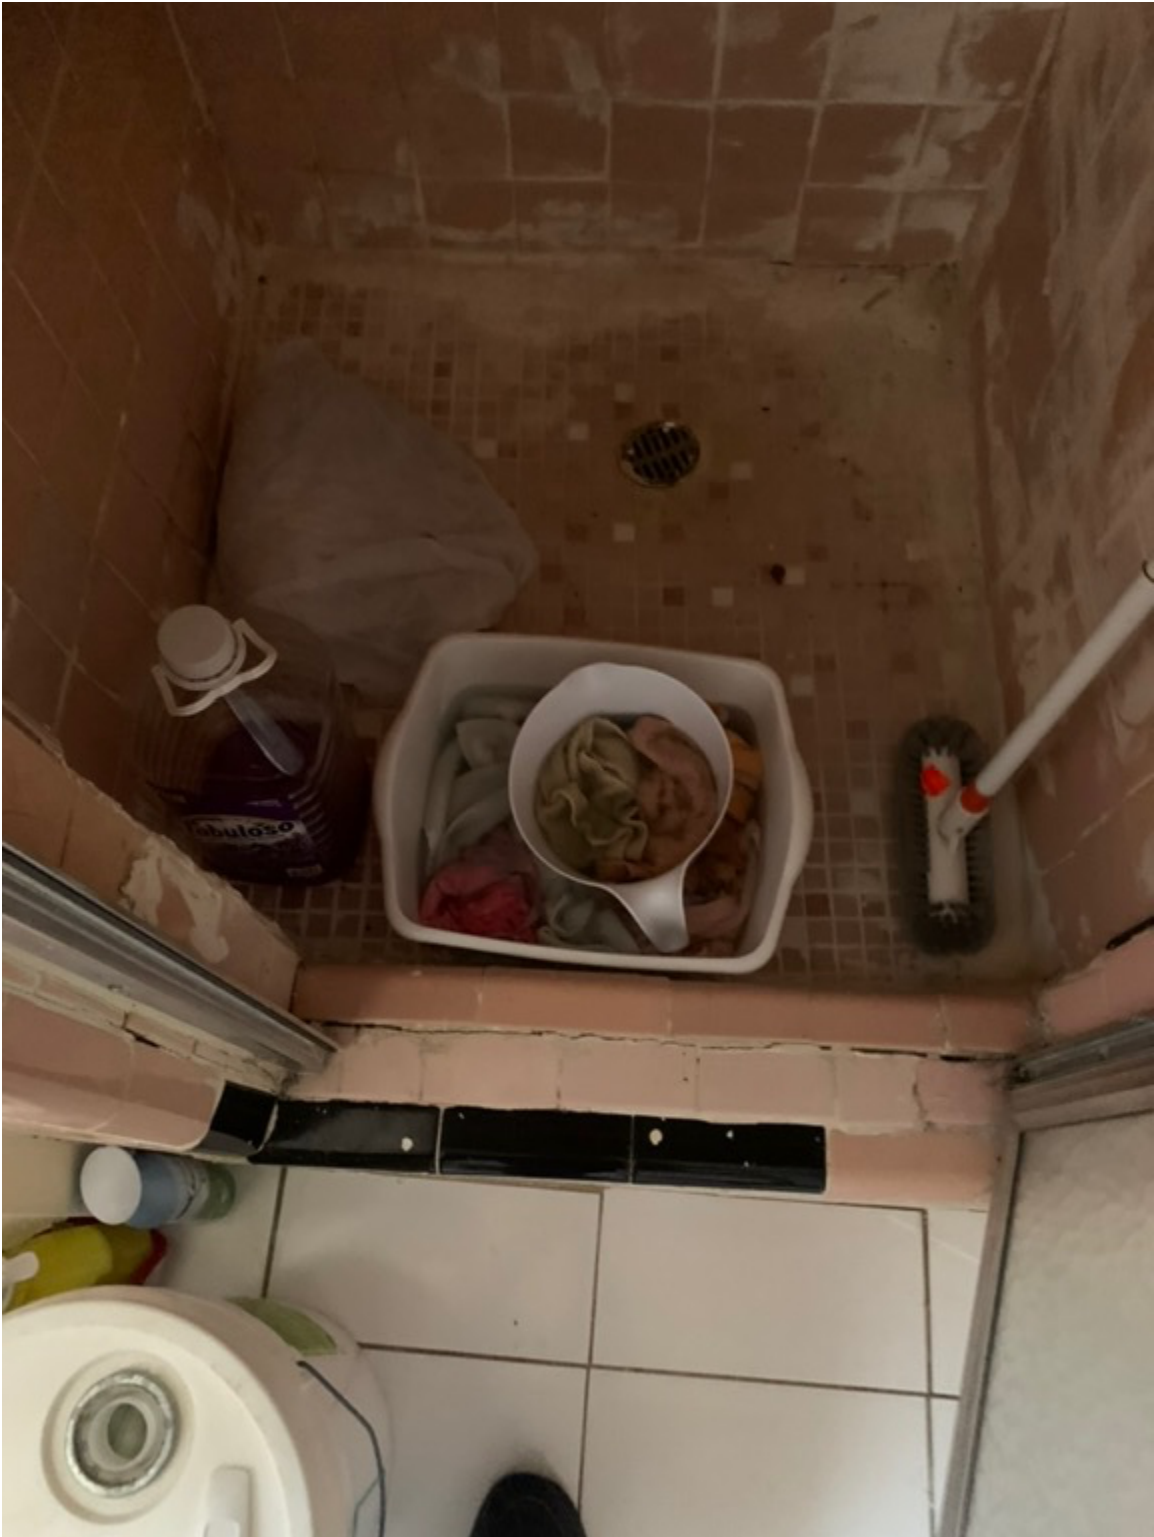
The bathroom shower does not work, and the family uses the bathtub with a flexible shower hose. The bathtub walls are not adequately protected from water damage. The shower is in very poor condition. The tiles only extend from the top of the tub to approximately 2.5 feet. This causes the upper part of the plaster wall to become wet. The tiles around the bathtub are in very poor condition. The tenant reports mold growth occurs around the windows, and condensation occurs on the windows primarily in the winter. This is caused by condensation, most likely due to radiator leaks and the poor insulating value of the windows.

The shower in 5F is in poor condition and cant be used

1. *Clean the bathroom walls, including the shower tiles with a strong detergent.*
2. *RegROUT the tiles around the tub.*
3. *Repair the bathroom shower and remove and replace the tiles so that it works properly and does not leak.*
4. *Clean the walls above the tiles around the bathtub in the bathroom and repaint.*
5. *Clean the walls and windows in the bedrooms and repaint.*
6. *Steam radiators should be inspected and repaired by a plumber to eliminate stem leaks that cause condensation.*
