# OLMSTED ENVIRONMENTAL SERVICES, INC

Mold Survey: 240 E 18th St, Brooklyn, NY, United States

Survey Date: July 24, 2023

PHOTOGRAPHS  
240 EAST 18<sup>TH</sup> STREET BROOKLYN NY  
July 24, 2023

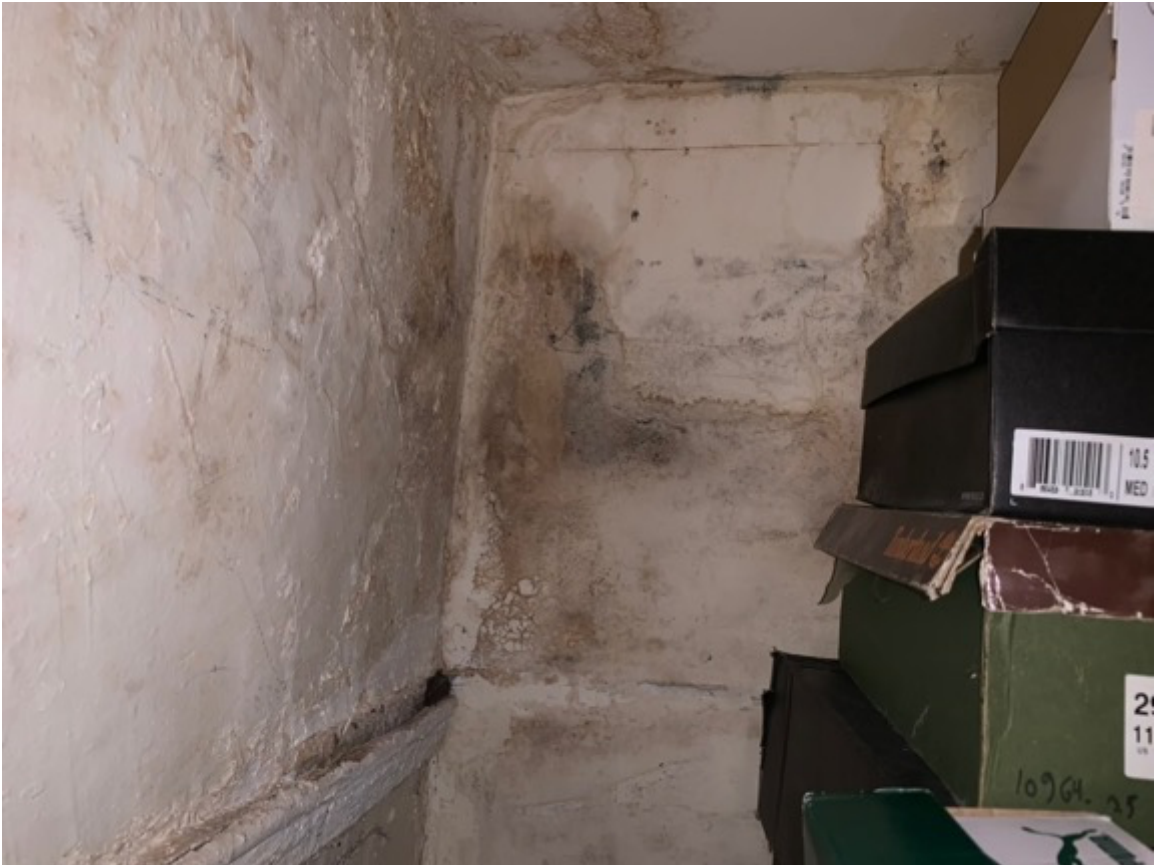
1. The plaster in the closet and living room was dry when tested with a moisture meter.
2. A tape lift sample was collected from the damaged paint on the back wall of the master bedroom closet. The sample, number 240E182C-21, was analyzed microscopically by Ed Olmsted and Prestige. The sample had heavy growth of *Stachybotrys*. A sample from the ceiling in the closet, number 240E182C-23, was analyzed by Ed Olmsted and Prestige. The sample had heavy amounts of fungal spores.

Moldy bedroom closet in 2C

1. *Remove the clothes from the bedroom closet and launder or dry clean*
2. *Remove, clean and scrape loose paint from the wood shelves in the closet.*
3. *Scrape the damaged paint and plaster and remove wood trim in the back wall and ceiling of the closet.*
5. *Scrape the damaged paint and plaster and remove wood trim in the master bathroom.*

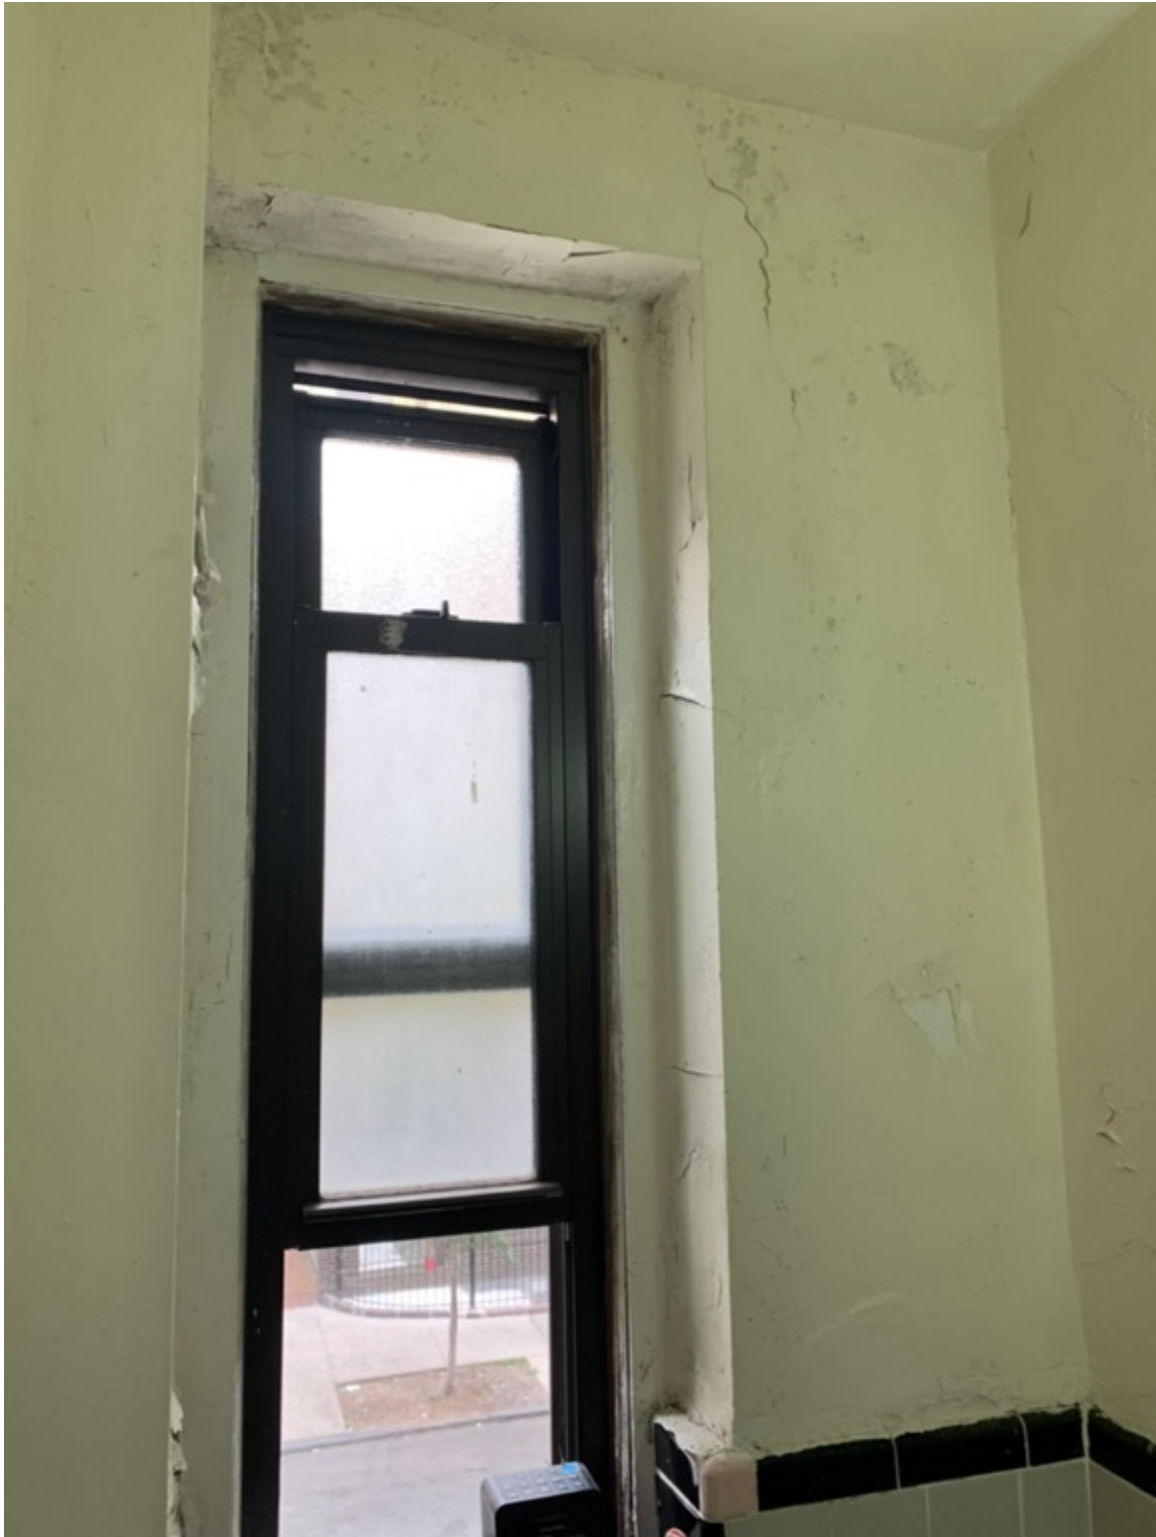
3. In the master bathroom, a tape lift sample was collected from the water-damaged wall, which had visible mold. The sample, number 240E182C-22, had moderate growth of *Cladosporium* and *Altenaria*.

Mold growth and water damaged in the 2C bathroom

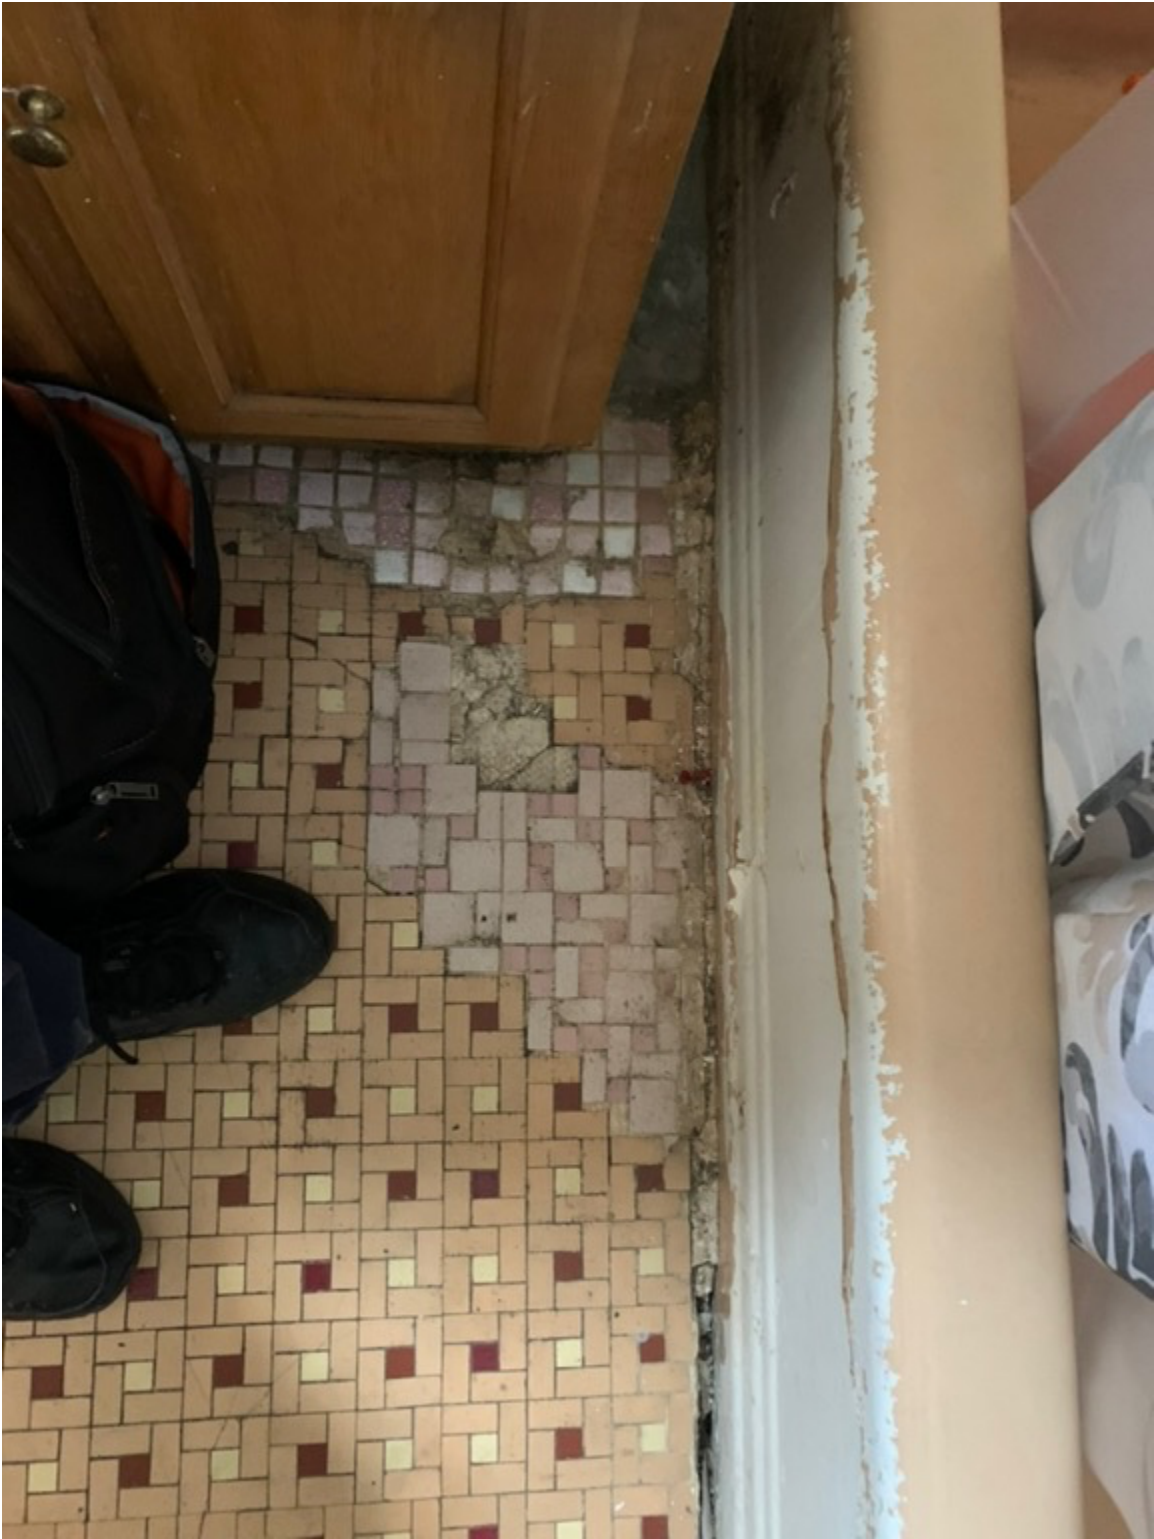
The bathroom is in poor condition. The floors are damaged, lifting up and in poor condition. The tiles around the bath are in poor condition.

The damaged floor in the 5B bathroom

1. *The bathroom should be renovated. Remove and replace the floor and tile walls around the tub.*
2. *RegROUT the tiles around the tub.*
3. *Repair the shower and regROUT the tiles so that it works properly and does not leak.*
4. *Clean the walls above the tiles around the bathtub in the bathroom and repaint.*
5. *Clean the door, walls, and windows in the bedroom and repaint.*
6. *A plumber should inspect and repair steam radiators to eliminate steam leaks that cause condensation.*

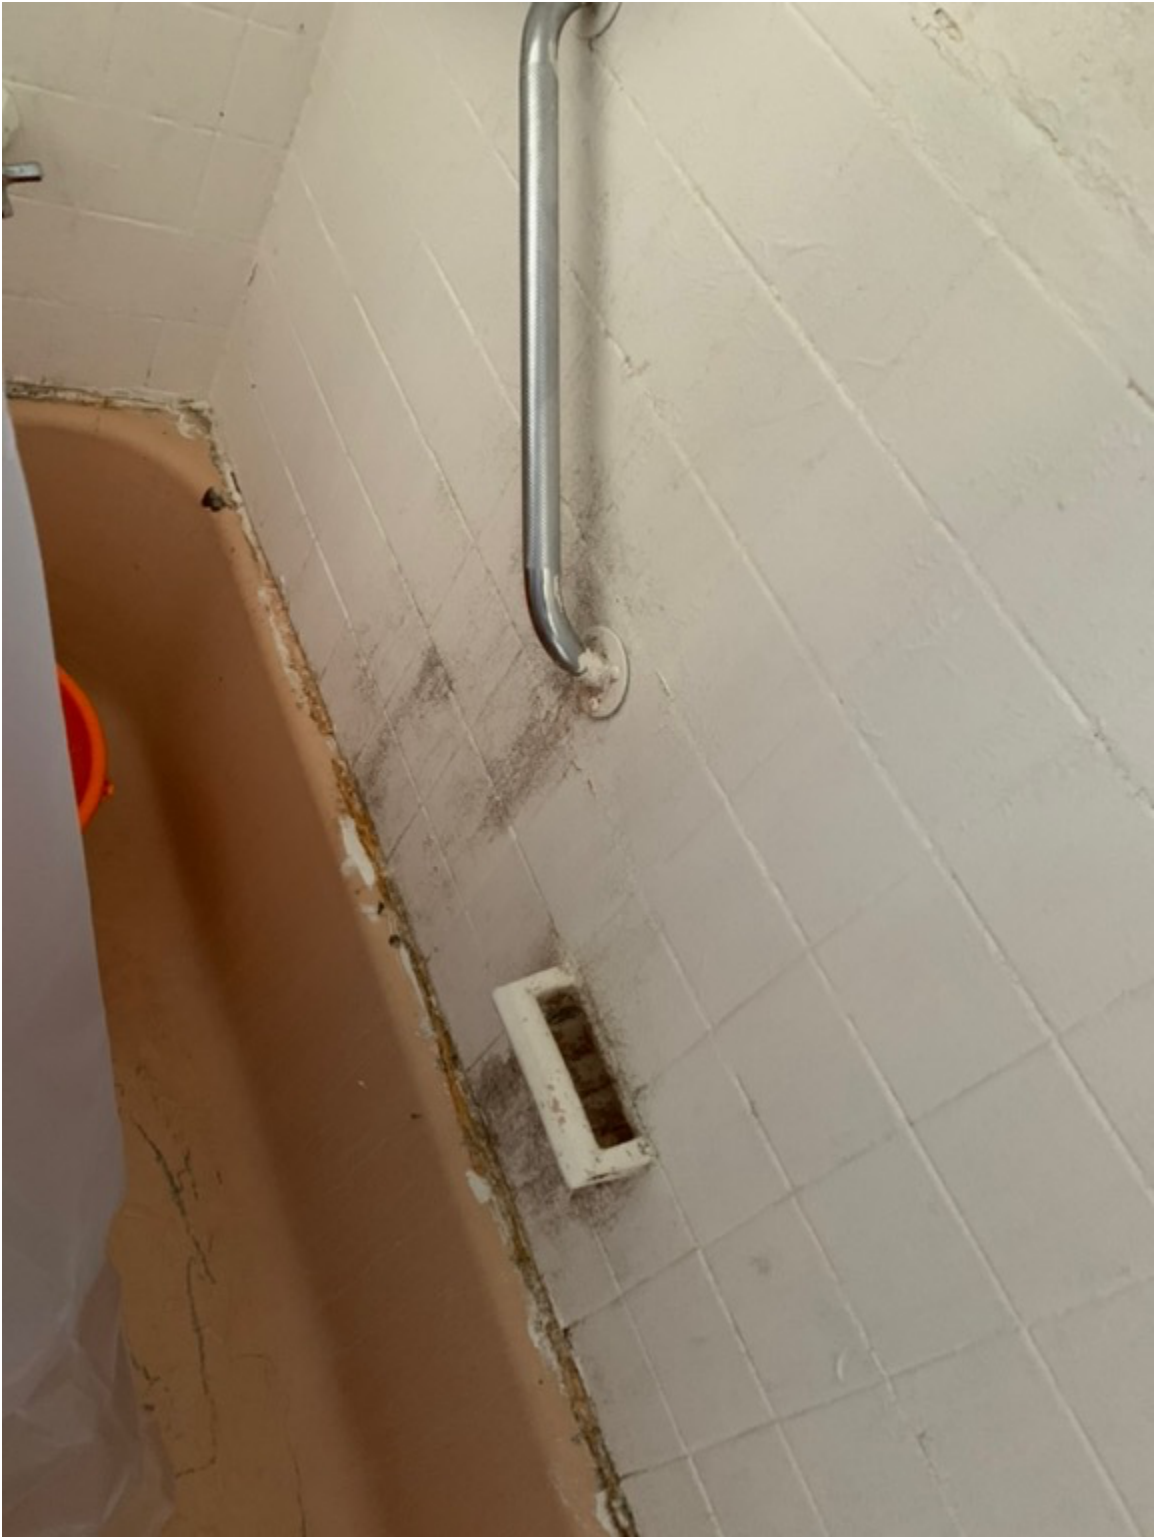
1. The bathroom tiles around the tub are cracked and lifting. The wall tests damp with a moisture meter, which indicates the tiles are leaking water into the wall. The tiles were painted in the past. This provides a substrate for mold growth and should not be done.

visible mold around the tub in 5B bathroom

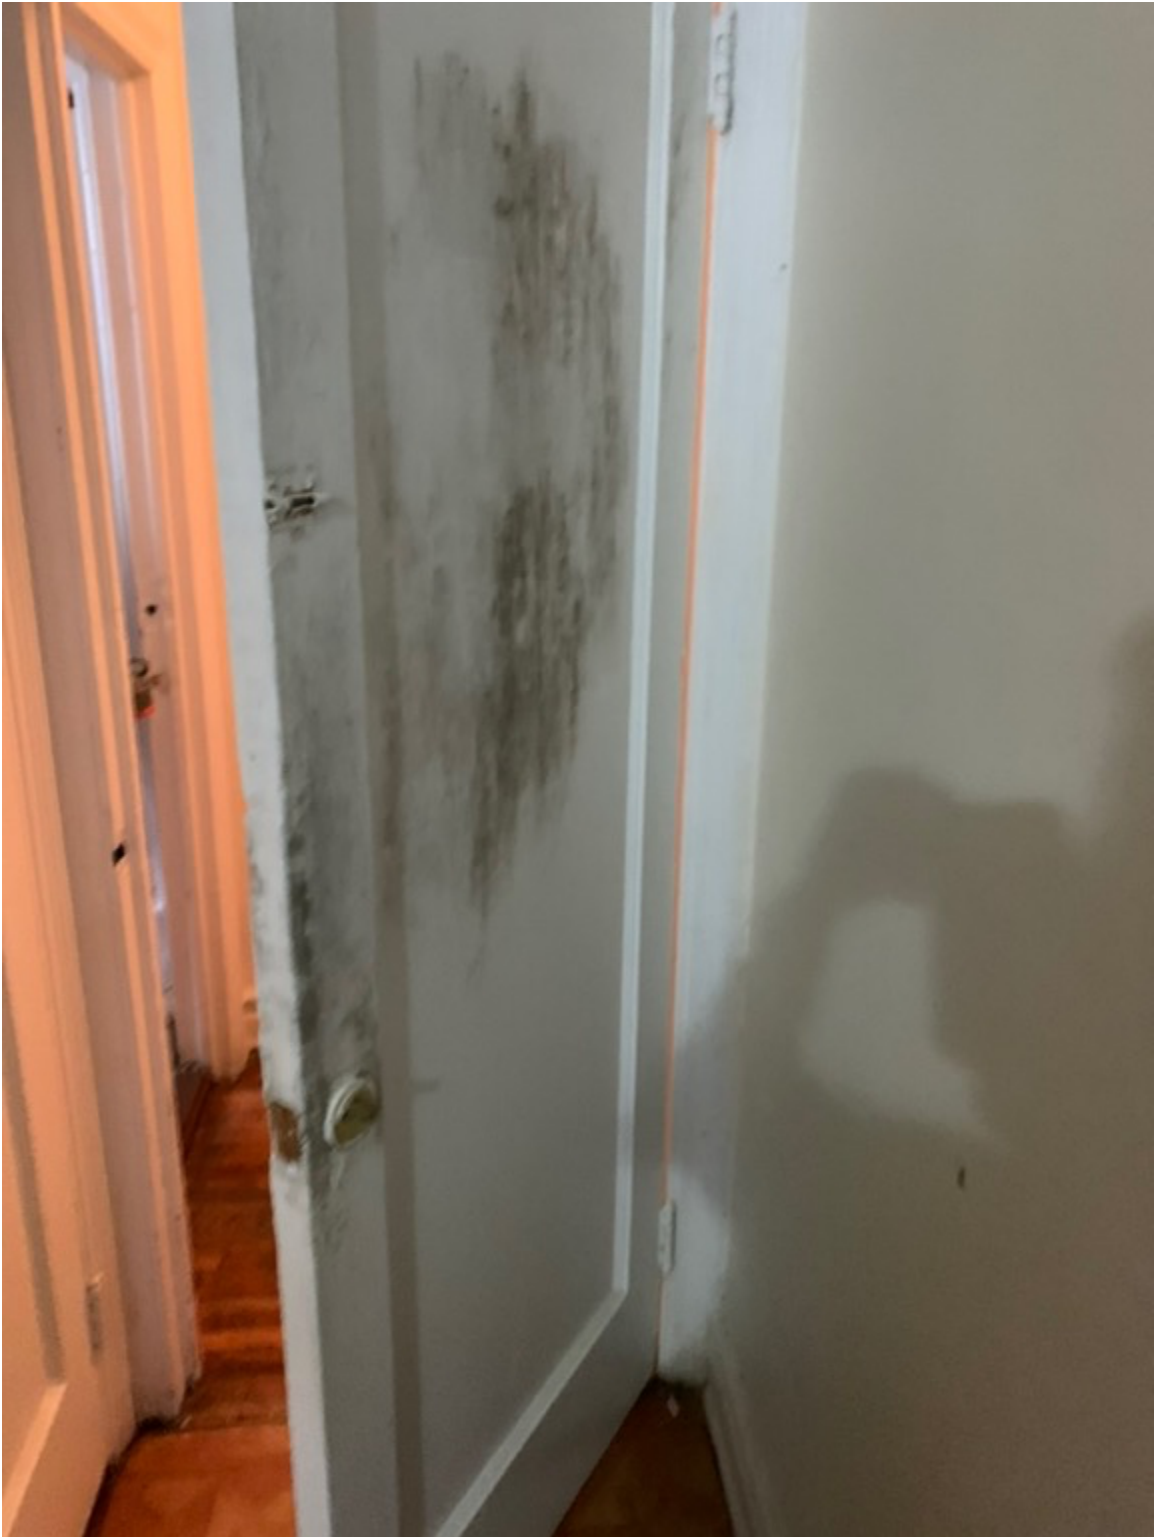
3. There have been episodes of condensation around the bedroom windows in the winter. This caused condensation and visible mold on the bedroom window and door. Two tape lifts were collected from each of the bedroom window and bedroom door. Sample 240E185B-28, from the bedroom window was analyzed by Ed Olmsted and Prestige. The sample had growth of mold evidenced by spores, hyphae and conidiophores of *Cladosporium*. Sample 240E185F-27, was from the bedroom door had spores, hyphae and conidiophores of *Cladosporium*, indicating growth. This confirms there is condensation and mold growth around the windows and on the door and is likely on other contents.

visible mold on the bedroom door in 5B

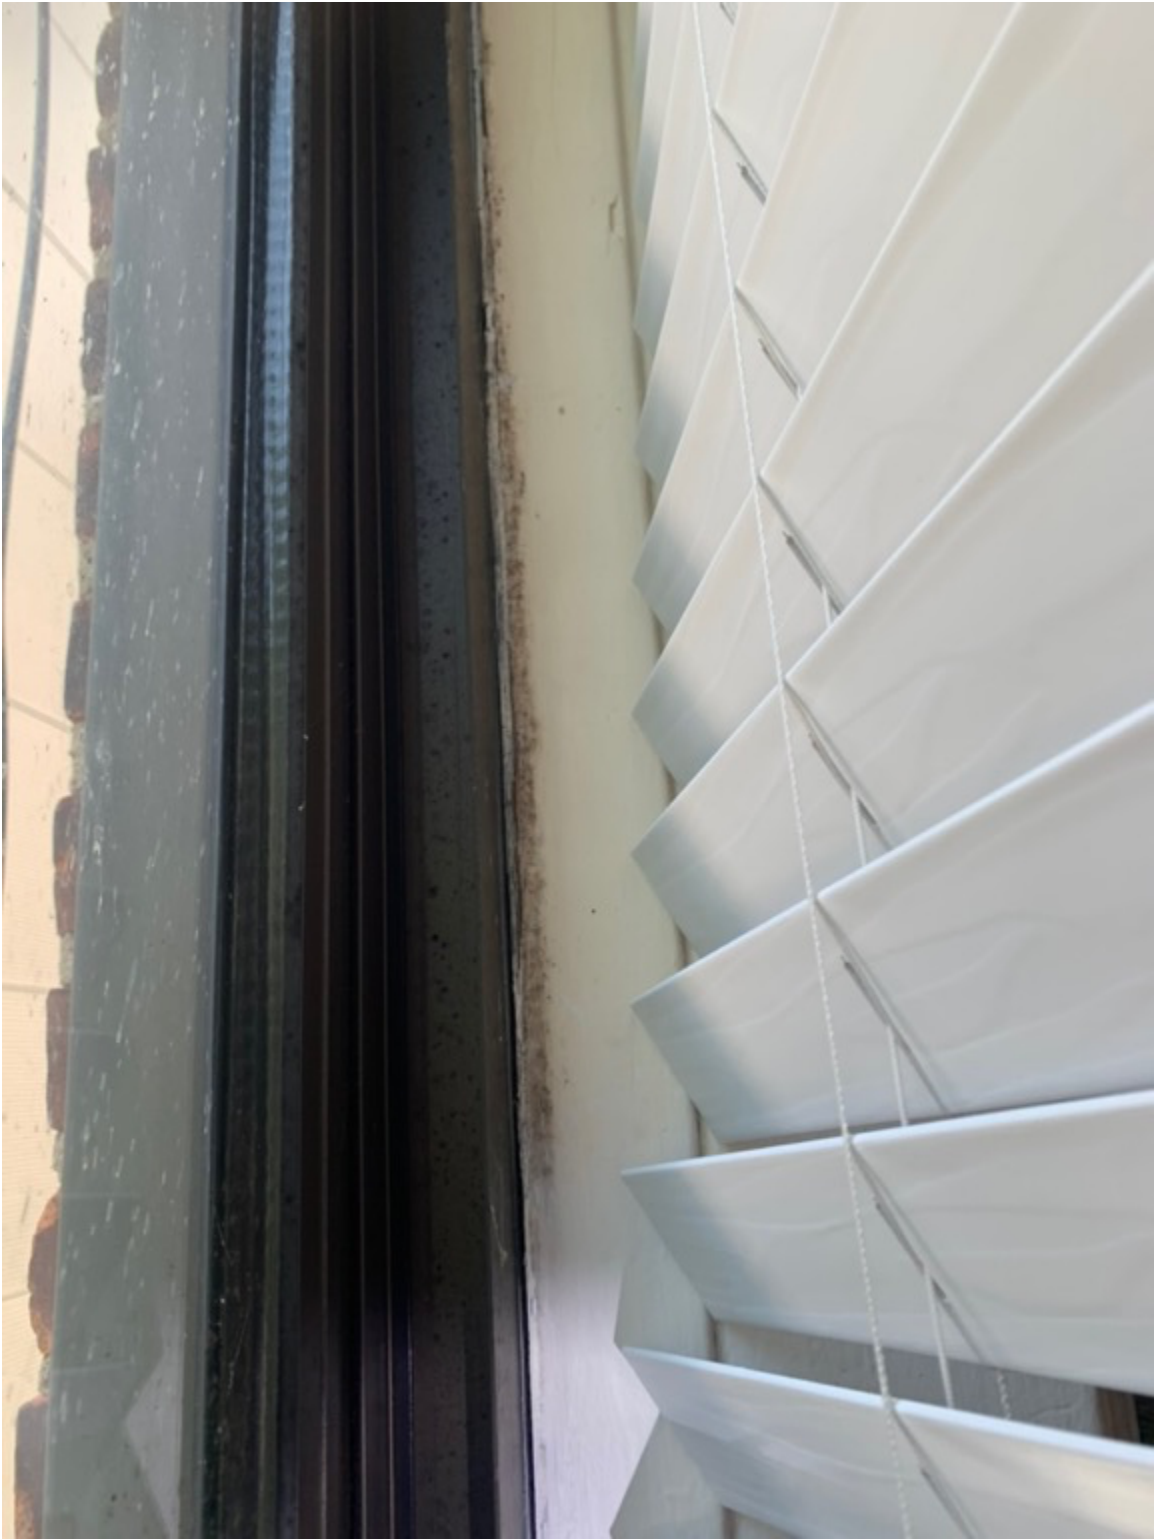
Mold growth around the windows in 5B
